HISTORIC PRESERVATION
CERTIFICATION APPLICATION-

PART 2

WEBBLEY

403 S. WASHINGTON ST

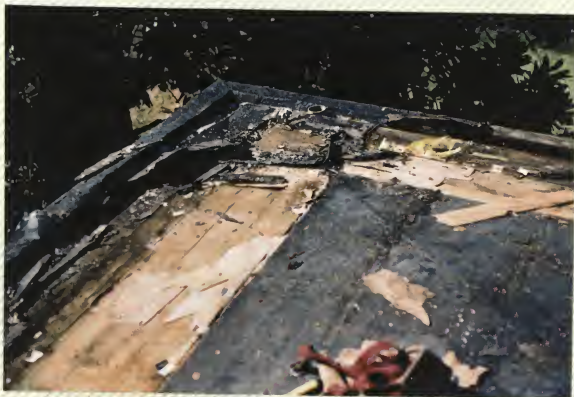
1-A

Describe existing feature and its condition: The main roof of the dwelling is covered with Victorian metal shingles in very poor condition. The metal shingles have not been painted in almost 20 years and have been severely damaged by rust and improper patching materials. The shingles have completely rusted away in seven locations creating major water problems in the attic and the second level rooms.

preserved. Deteriorated historic features shall be repaired and restored rather than replaced. Where the severity of deterioration requires replacement, the new feature will match the old in design, color, texture, and other visual qualities including material (if possible). These standards will be followed as to all work outlined in this application. Specifically, will hand clean rust and tar as necessary from all metal shingles. Will purchase identical replacement shingles from manufacturer in Nevada, Missouri, and will only replace the metal shingles that have been completely rusted out. Will seek to avoid replacement of metal shingles whenever possible. Metal shingles will then be prepared for painting and will be coated with two coats of a black metal roof paint.

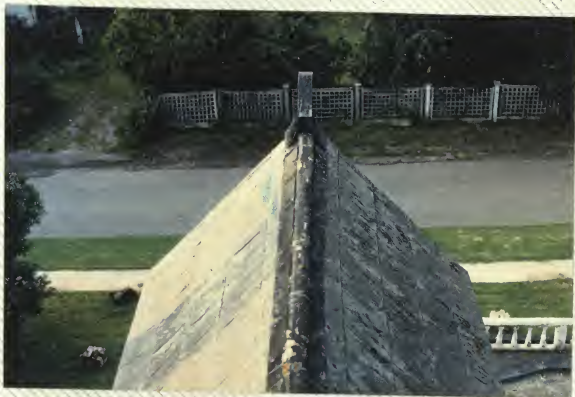
2-C

Describe existing feature and its condition: The main roof of Victorian metal shingles is accented by gabled attic dormers centered on its west and north slopes. Each dormer contains a fanlight window over two ventilator type windows. The dormers are in generally good condition with the exception of the Victorian metal shingles (see number 1 above). However, the wood and windows have been severely weathered over the years.

craftsmanship that characterize this part of the property will be preserved. Deteriorated historic features shall be repaired and restored rather than replaced. Where the severity of deterioration requires replacement, the new feature will match the old in design, color, texture, and other visual qualities including material (if possible). These standards will be followed as to all work outlined in this application. Specifically, as to this feature all of the windows will be re-glazed and glass panes replaced as necessary (the existing panes were added in the 50's). The loose paint will be scraped by hand. No chemicals or heat will be used. The wooden joints between the lap boards will be re-caulked; the wood will be oiled; and the wood will be painted. No changes will be made in the physical appearance of the dormers.

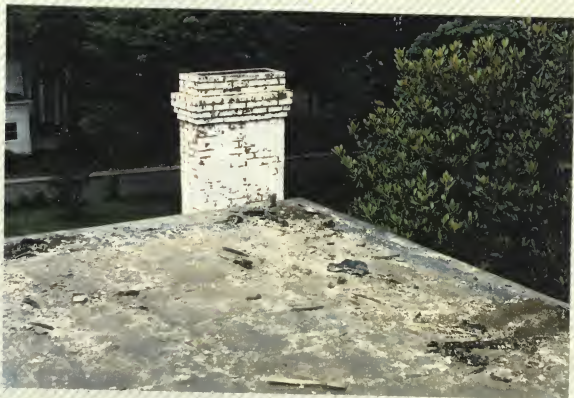
3-A

Describe existing feature and its condition: The balustrades on the flat roof deck of the main roof are turned with square end section posts. The roof deck is rectangular in shape and the balustrades follow the outer lines of the deck. A pair of interior chimneys rise near the east end of the north and south sides of the deck. The balustrades run between these two chimneys at this point on the deck. The balusters are broken and missing at many points and over 95% of the balusters are in such

condition that they cannot be repaired and restored. The square end section posts are generally in the same condition and beyond repair. These wooden members were neither painted nor maintained for more than 20 years and the elements have simply taken their toll.

Describe work and impact on existing feature: Distinctive features, finishes, and construction techniques or examples of craftsmanship that characterize this part of the property will be preserved. Deteriorated historic features shall be repaired and restored rather than replaced. Where the severity of deterioration requires replacement, the new feature will match the old in design, color, texture, and other visual qualities including material (if possible). These standards will be followed as to all work outlined in this application. As to this part of the project, identical balusters will be purchased and affixed to the flat roof deck on the main roof. The rails will be produced locally in the same design and of the same wood so as to match the original rails. The rails and balusters will then be assembled by hand on site with each baluster the same distance apart as the old balusters. The balusters along with the top and bottom rails will then be affixed to the flat roof in the same location as the old structure. The square end section posts will be constructed on site to match the old rotten posts. The wood members will then be sealed and caulked and painted to match the exterior paint for the dwelling.

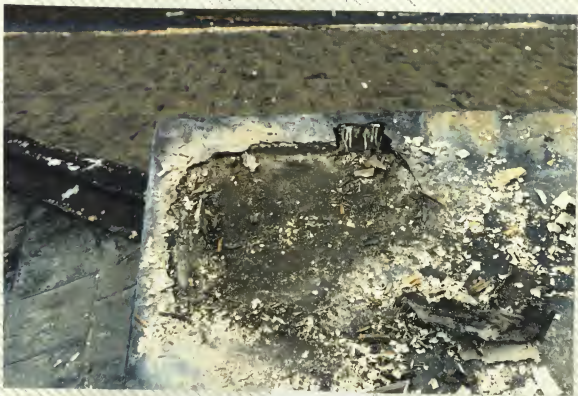
4-C

Describe existing feature and its condition: The west side of the home is dominated by a symmetrical three-bay front, with a full height central bay supported by fluted Ionic columns. The roof of each bay is covered by 3 X 5 and 2 X 4 sheets of flat metal. The metal has not been maintained and is rusted and separated at many of the joints. All of the flat metal suffers from heavy rust damage due to lack of maintenance.

Describe work and impact on existing feature: Distinctive features, finishes, and construction techniques or examples of craftsmanship that characterize this part of the property will be preserved. Deteriorated historic features shall be repaired and restored rather than replaced. Where the severity of deterioration requires replacement, the new feature will match the old in design, color, texture, and other visual qualities including material (if possible). These standards will be followed as to all work outlined in this application. As to these areas, all of the rust will be removed by hand from the flat metal. The joints will be re-joined in the same manner as they were originally affixed as necessary and the flat metal pieces that have been completely rusted out will be replaced by identical flat metal pieces. All of the tar and other petroleum products will be removed from the metal surfaces. The metal will then be properly prepared for painting and will be painted with a black metal paint.
